The landslide occurred on March 30, 2011. The maximum rainfall ( $53.1 \text{ kg/m}^2$ ) has been seen in this month during a year. There is igneous rock that composed of tuff, andesite, dasite and basalt on the top of metamorphic schist, graphitic schist and serpentine. There are also basalt and limestone blocks. These blocks were split by fault and moved. The landslide body is consisting of schist and completely ripped dacite and andesite blocks. The basement is saturated serpentine which is very weak competent. There is clay zone inside these serpentines. These clay zones are turned into graphitic schist that is splitting surface of the landslide body. The reconstruction of highway was made according to Geophysical investigation result.

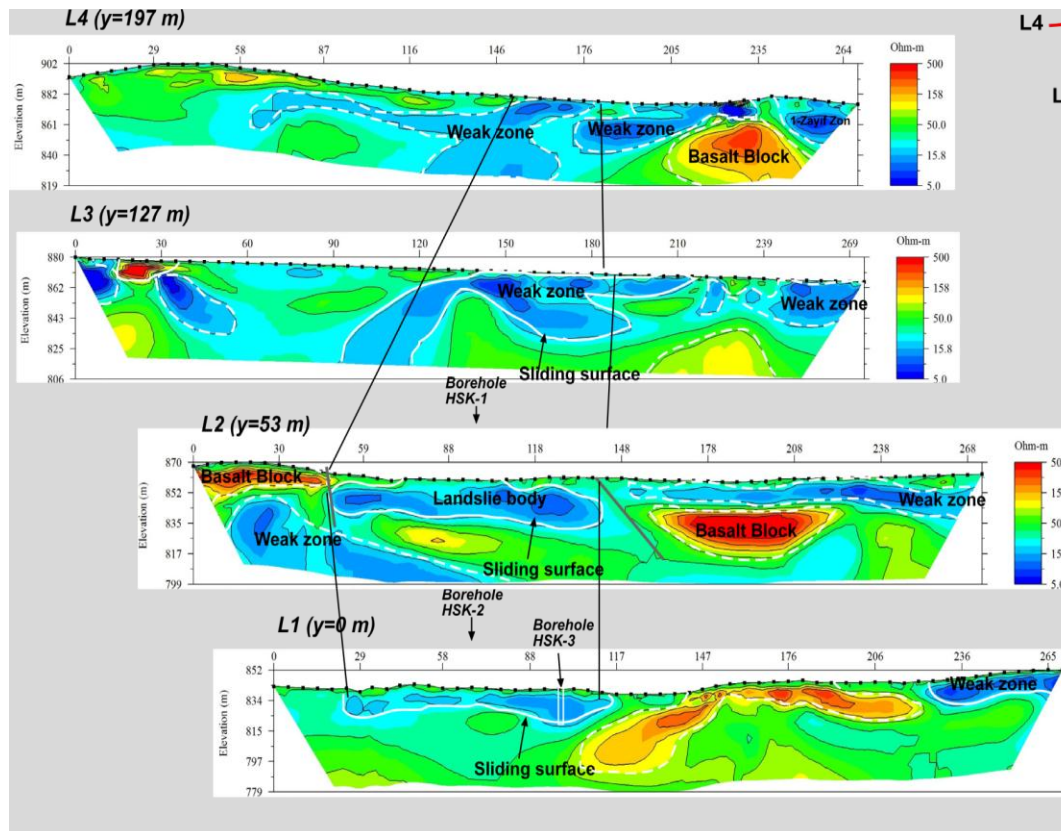
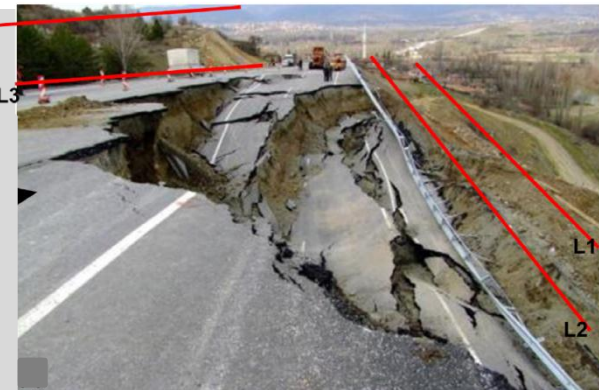
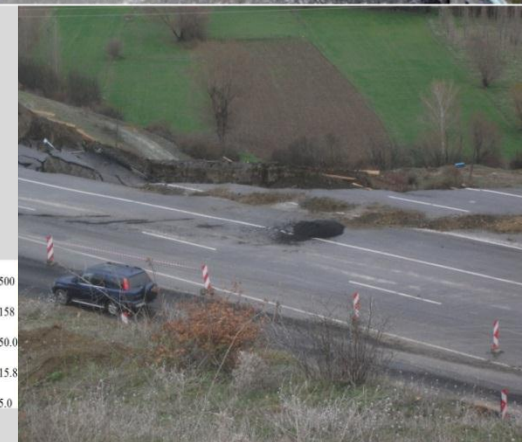
Instrument : SuperSting R8/IP+112

Electrode array : Dipole-Dipole and Pole-Dipole

Processing : Inversion of data using EarthImager 2D inversion software

Units : Meter and Ohmmeter
